# The Burden Lake Dam System:

1831 - 2024

by Larry McKeough

in conjunction with The Burden Lake Preservation Corporation

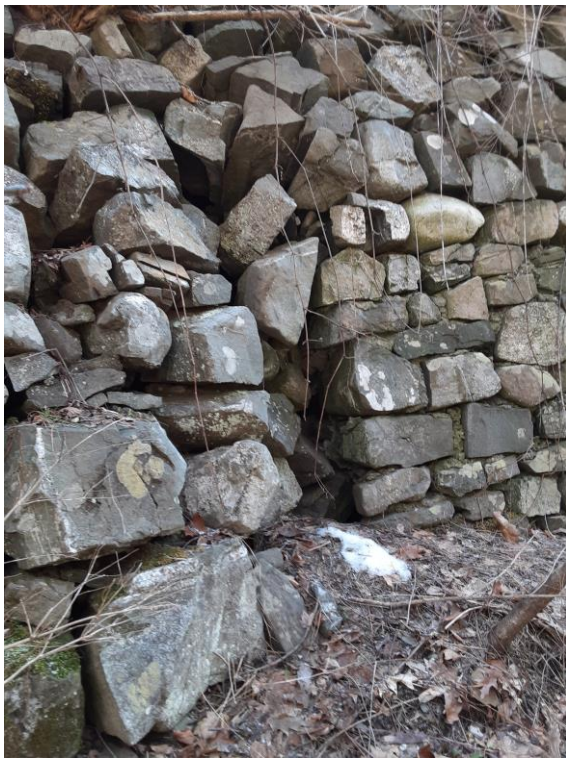
- The stones of the west wall appear to be moving.
- There is hole about 6' in the stone face on the west side with gravel below it.
- There are stress cracks all through the fairly new blacktop in the road atop the dam.
- The Town installed a sewer line at least 8' deep the length of the dam in 1982.
- There are 2 manholes in the dam approximately 10' deep into the structure.
- The 30" drain pipe's valve is inoperable and the west side of the pipe is capped off.
- **The dam, designed in 1863, was never designed to handle the amount of traffic and size and weight of the vehicles that were traveling over the dam prior to its closing.**

One spot where stones have moved

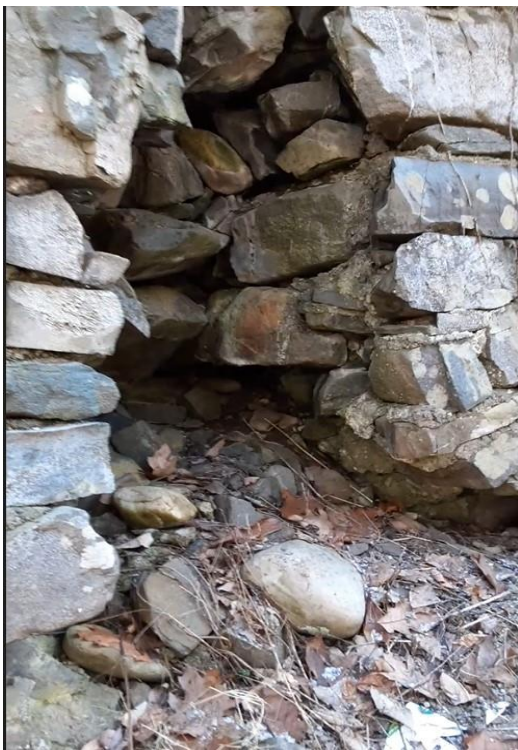
Close up of the 6' hole

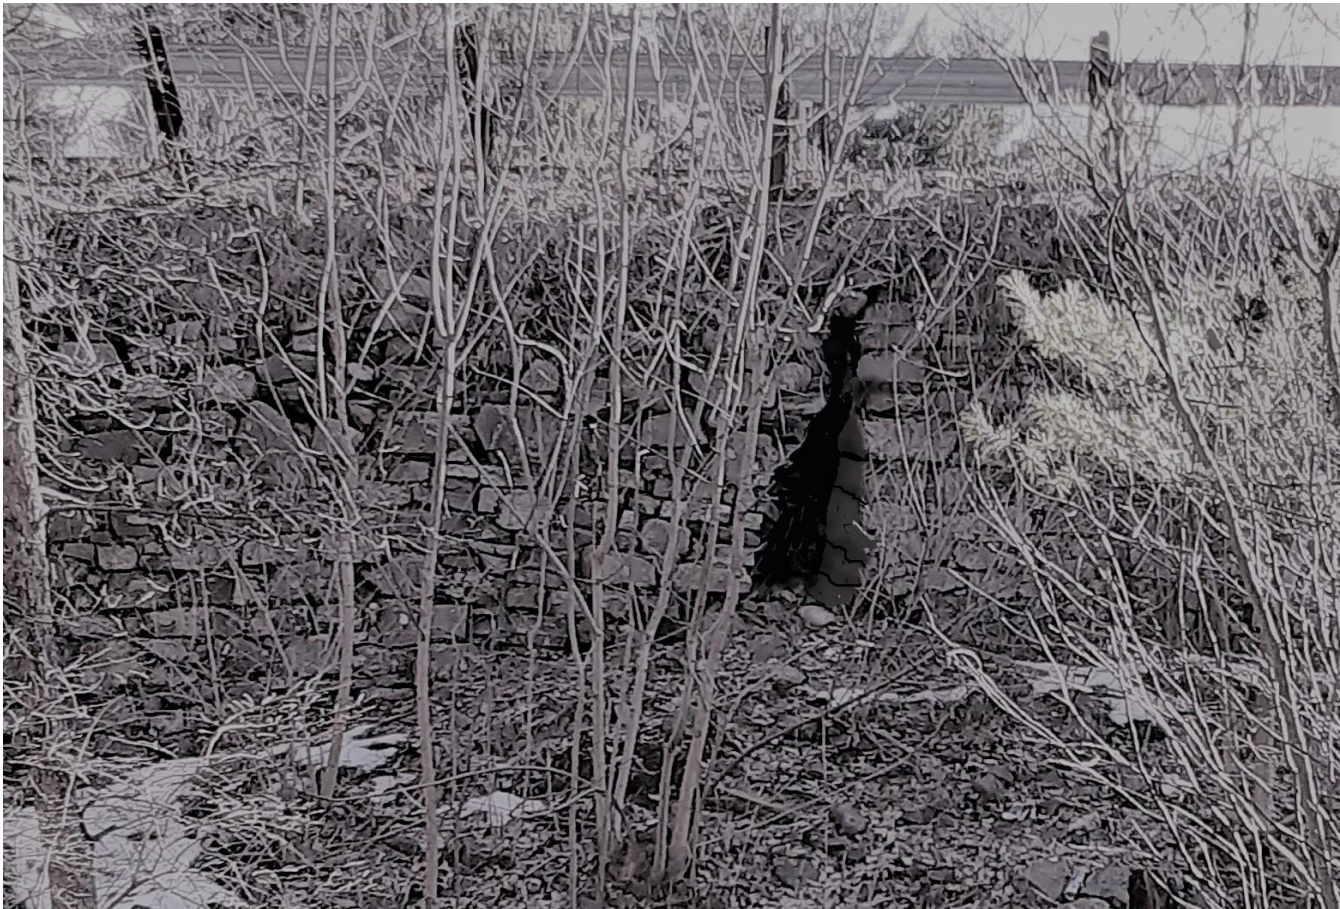
6' Hole in face of wall. Stones left of hole appear to be collapsing.

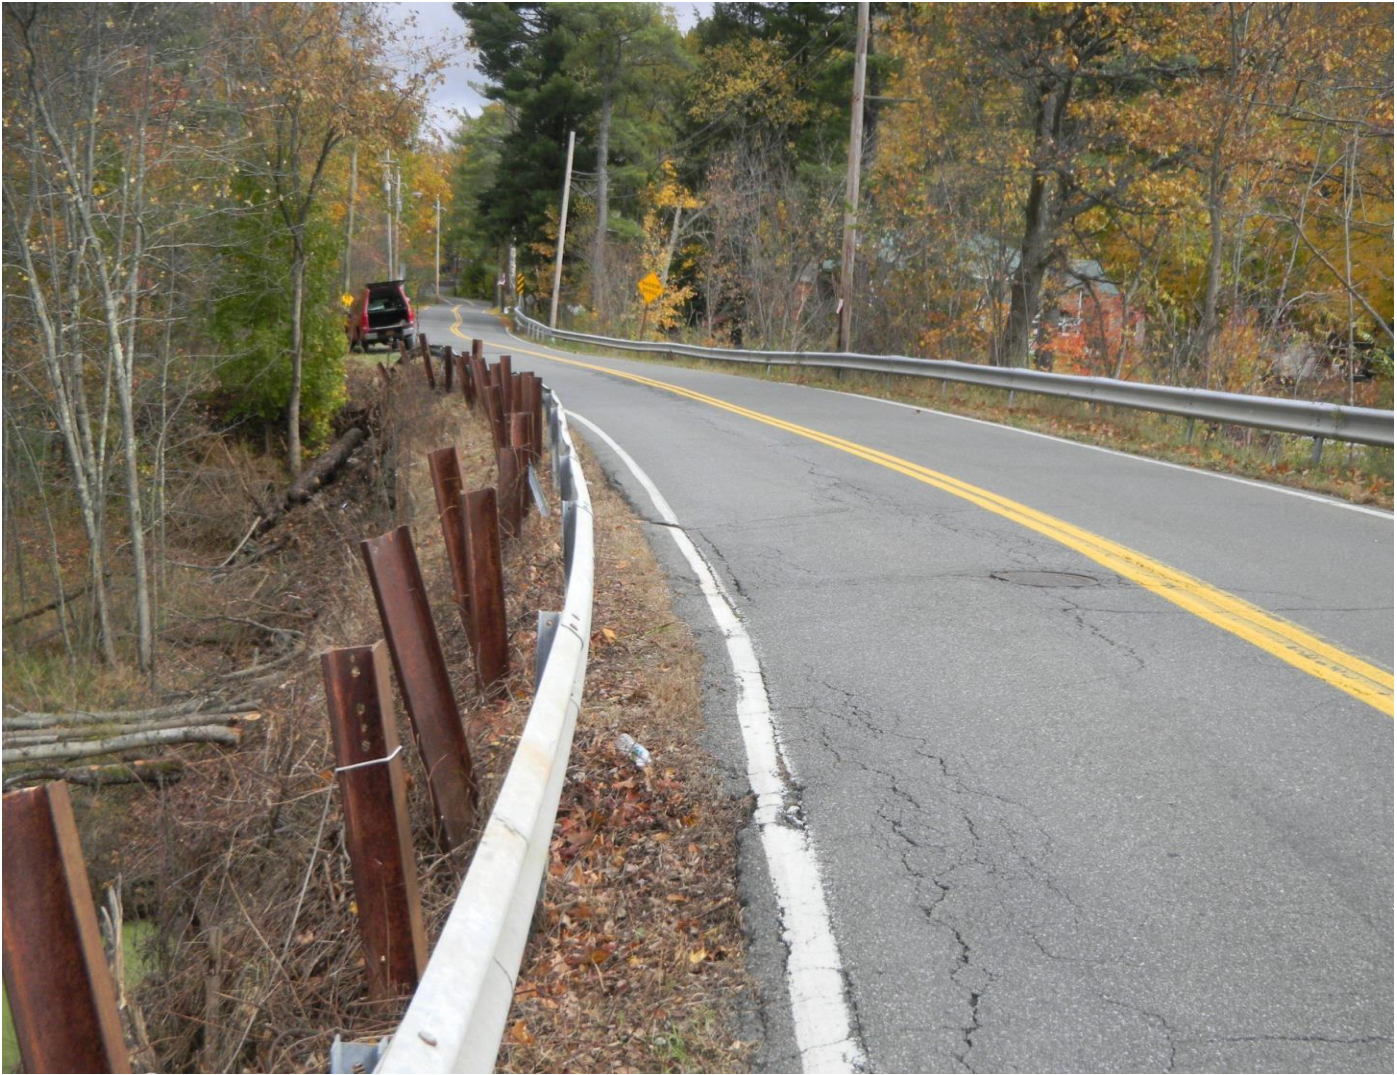
There are many Stress cracks in the road on top of the dam

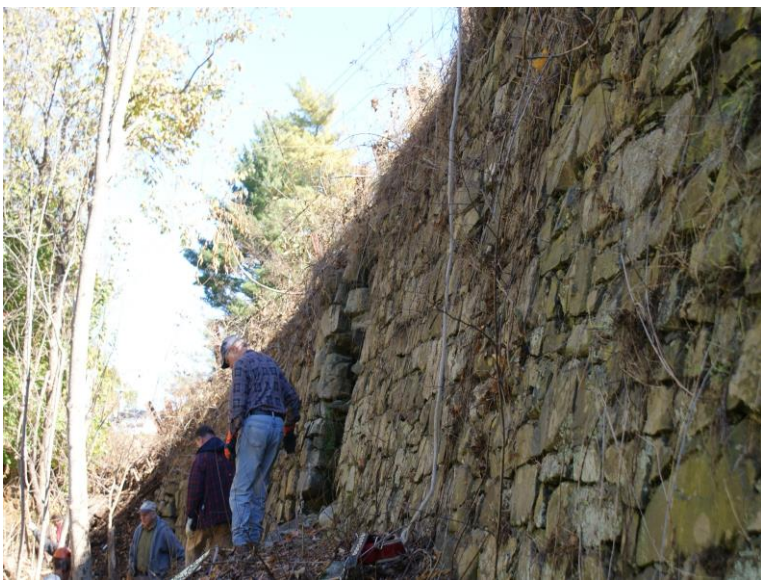
Man, next to 6' hole

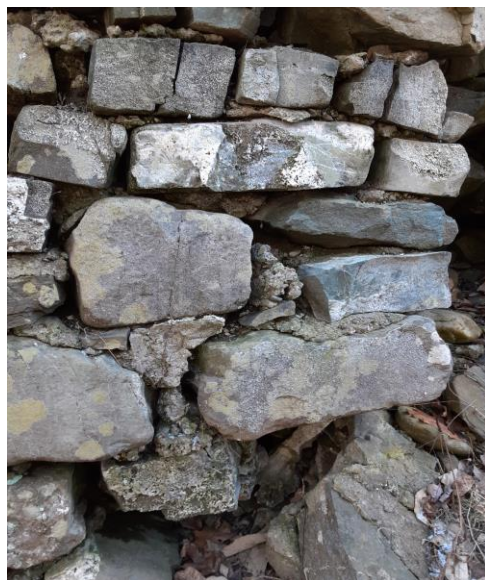
More lose & moving stones

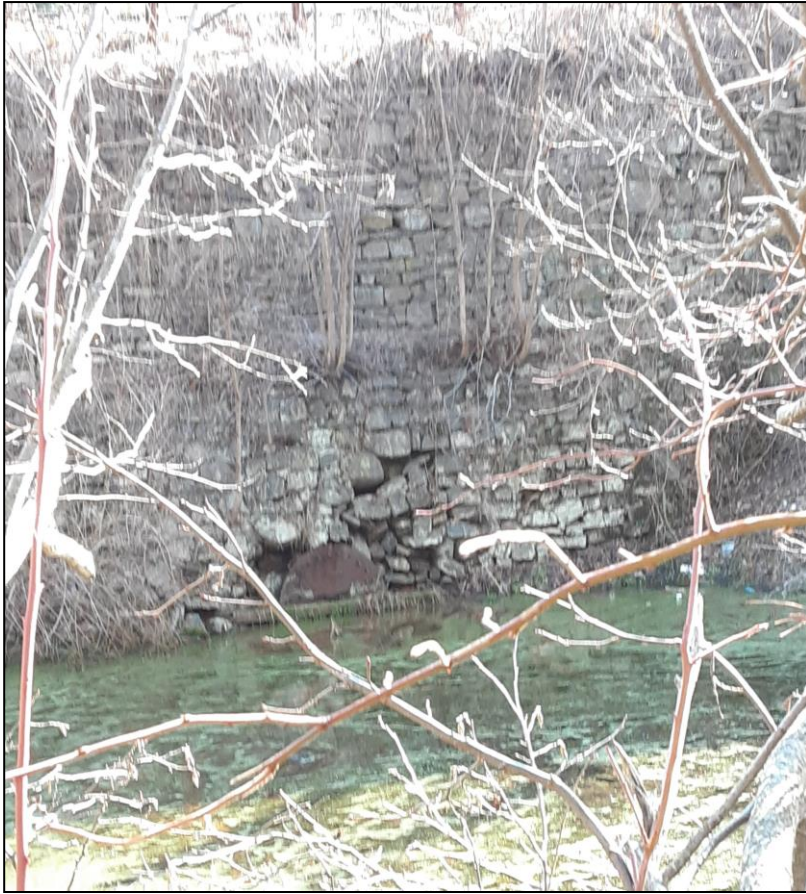
Loose stones around outlet pipe

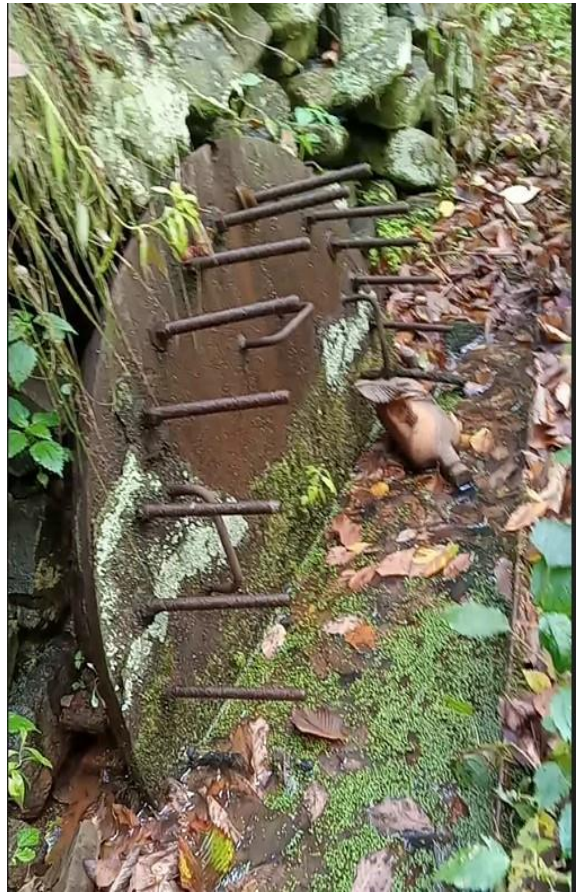
30" pipe capped off

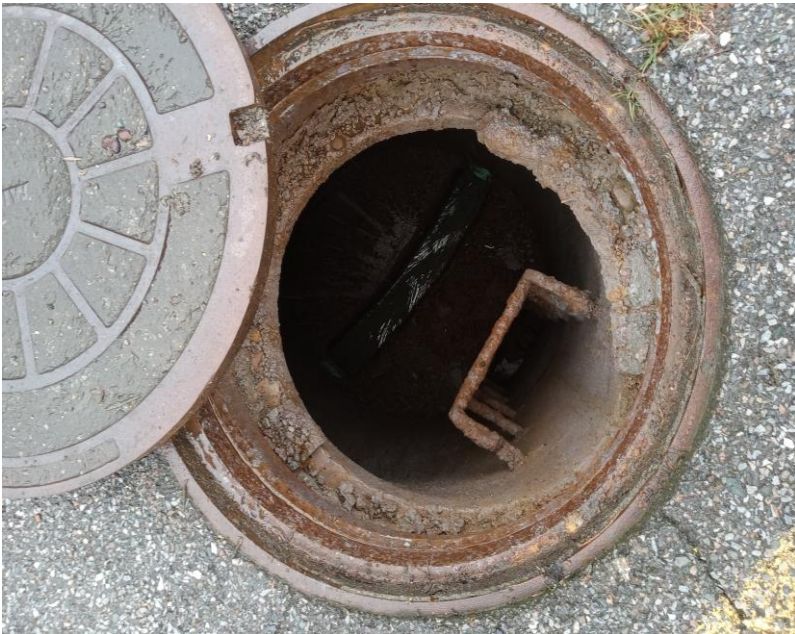
Sewer manhole at least 10' deep.

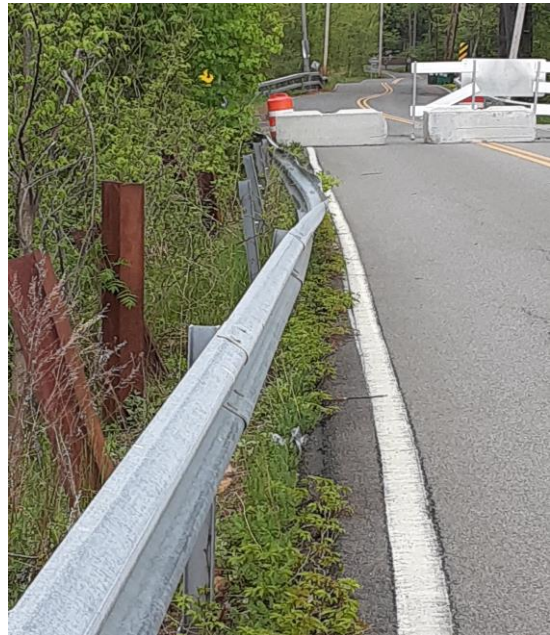
Road closed, guard rails and supports separated and unstable.

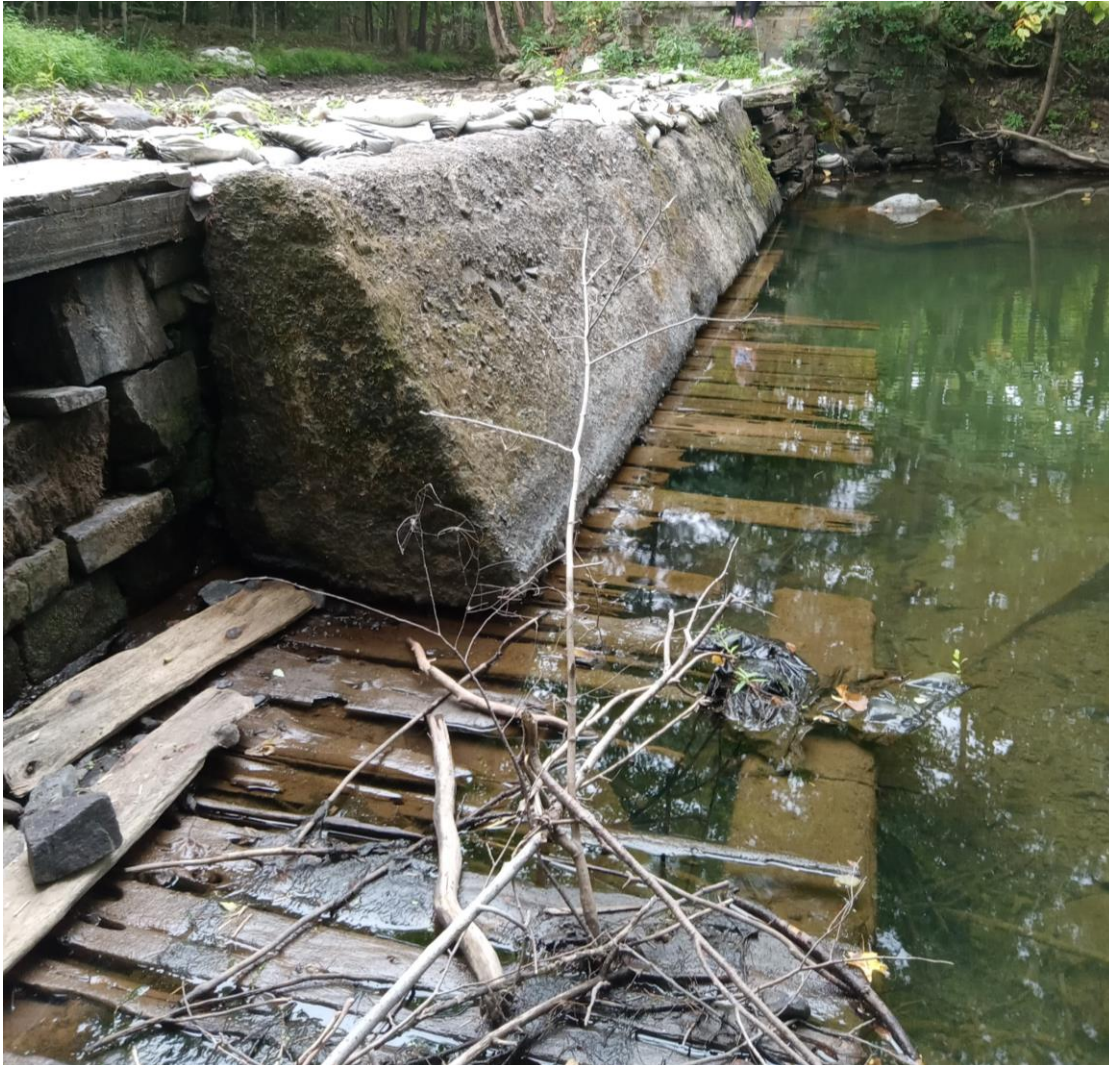
- Originally built of wood which washed away in the storm of 1891 and replaced with a concrete and cut stone structure in 1892.
- The current weir is four to five feet high, four to five feet thick, and fifty to sixty feet in length. Its cut-stone abutments on either side are failing.
- Is in unbelievably bad condition. Part of the weir fell apart and was repaired with railroad ties in the 1970's and are still in place today rotting away.
- The large granite capstones, which set the "normal" level of the 3 lakes, have all been washed off the top of the Weir with sandbags taking their place, temporarily.
- The structure is leaking in numerous places including through the 1970 temporary repair.
- The boards under the Weir appear to be deteriorating.
- The Weir has reached the end of its useful life at 130+ years old.

Weir photos were taken during drought of 2022 revealing the deteriorating condition of the structure including rotting boards underneath the Weir.

1. Build a construction service road from the dam on B/L Road to the Weir
2. Completely replace the Weir with the elevation set at the exact same historic elevation, incorporating a "fish ladder," if needed
3. Remove all trees and brush from the 900-foot berm; raise the Berm to 632.68' above sea level and widen the berm sufficiently to prevent a future breach. Hydroseed the top and west side of the berm. Install riprap on the east side of berm to reduce erosion.
4. Utilize the original 30-inch exit pipe under the dam by incorporating a standpipe/repared control valve (on the lake side of the dam) to allow us to make a combination drop drain and give us the ability to release excess water as needed.
5. Repair and strengthen the west side of the dam under the closed portion of Burden Lake Road
6. Divert water and snow melt from flowing off the roadway and down the west face of the dam

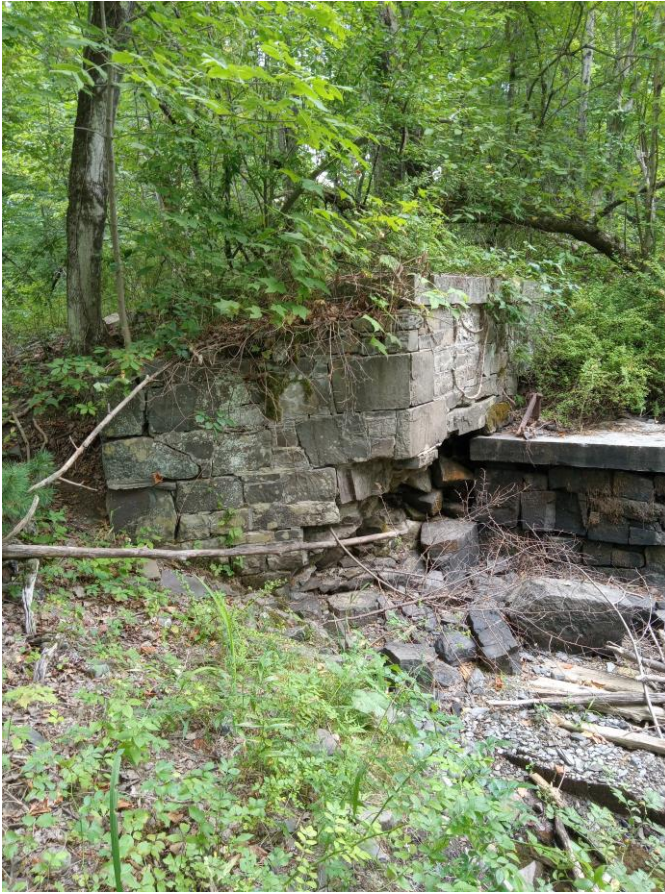
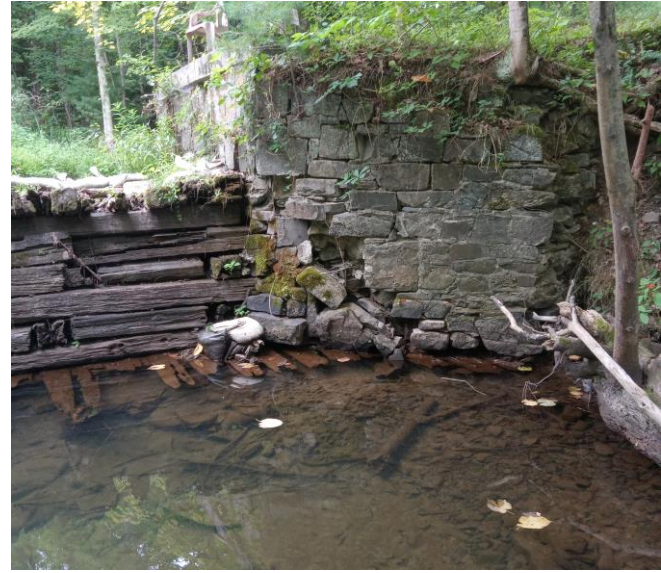
Above - Southeast Abutment  
Left – Northwest Abutment  
Both falling apart!

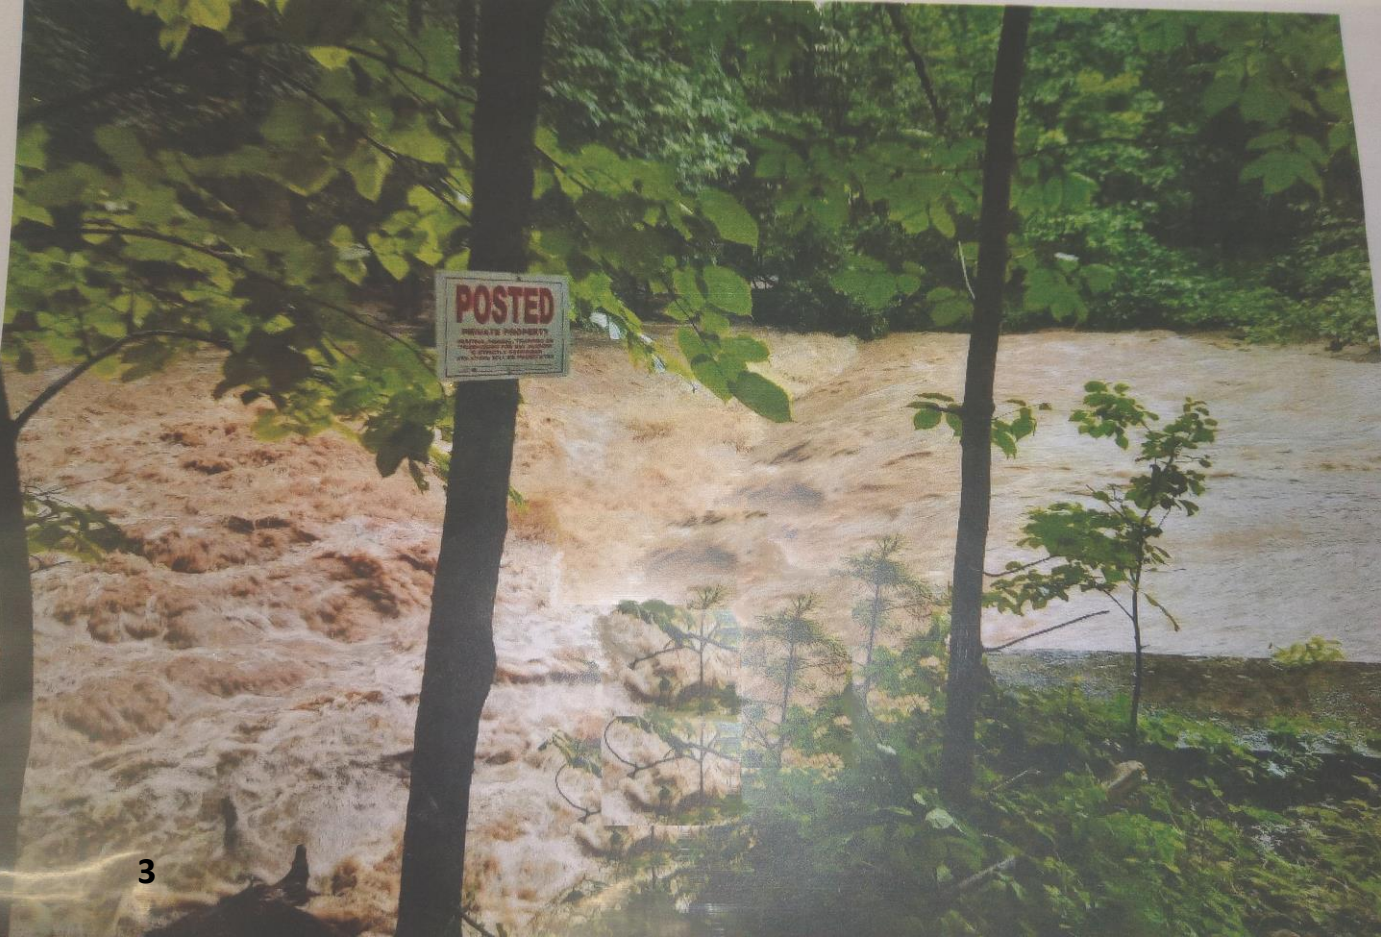
Flood of 2021 had 3 feet of water going over the top of the Weir for several days!

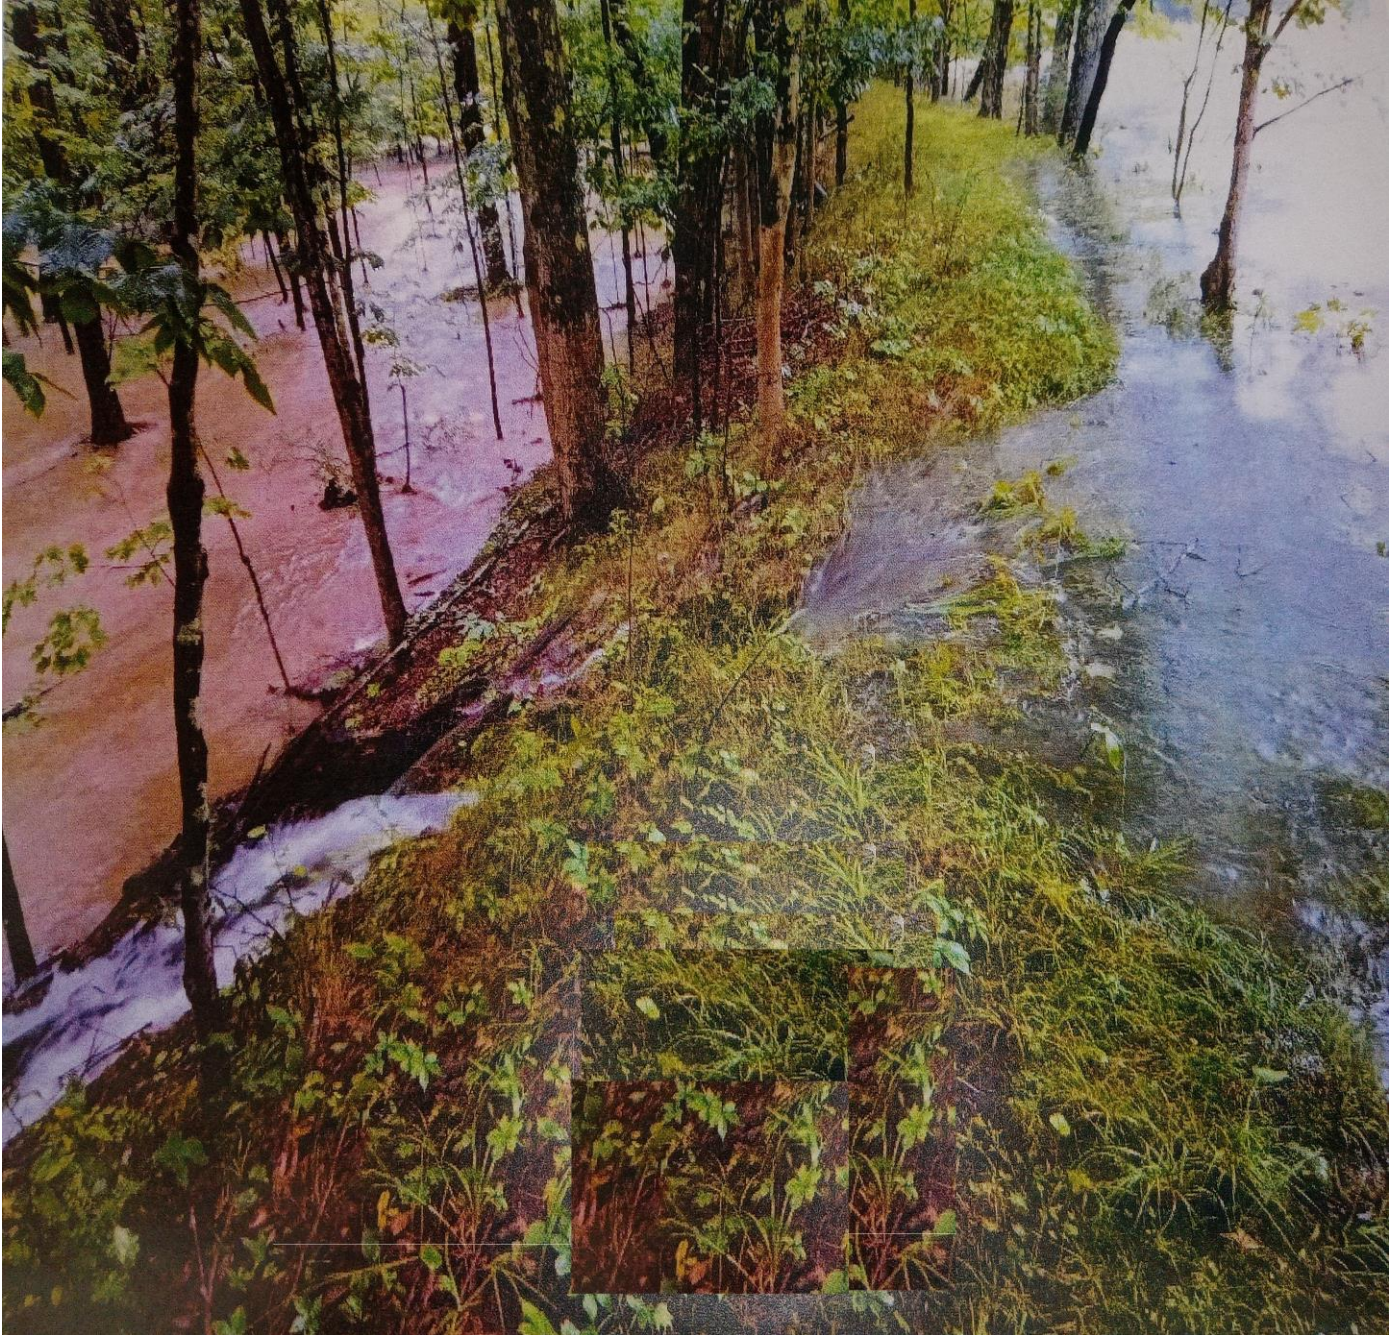
Canal to right, water flowing over berm into the woods. Photo during flood of 2021

- Needs to have all the vegetation including trees removed.
- Must be raised to 632.68' above sea level (3' higher than the high-water mark) and widened sufficiently to prevent breaching during large storms and high-water events.
- Needs rip rap installed on the east side to help prevent erosion.
- Needs grass planted along the top and west side.

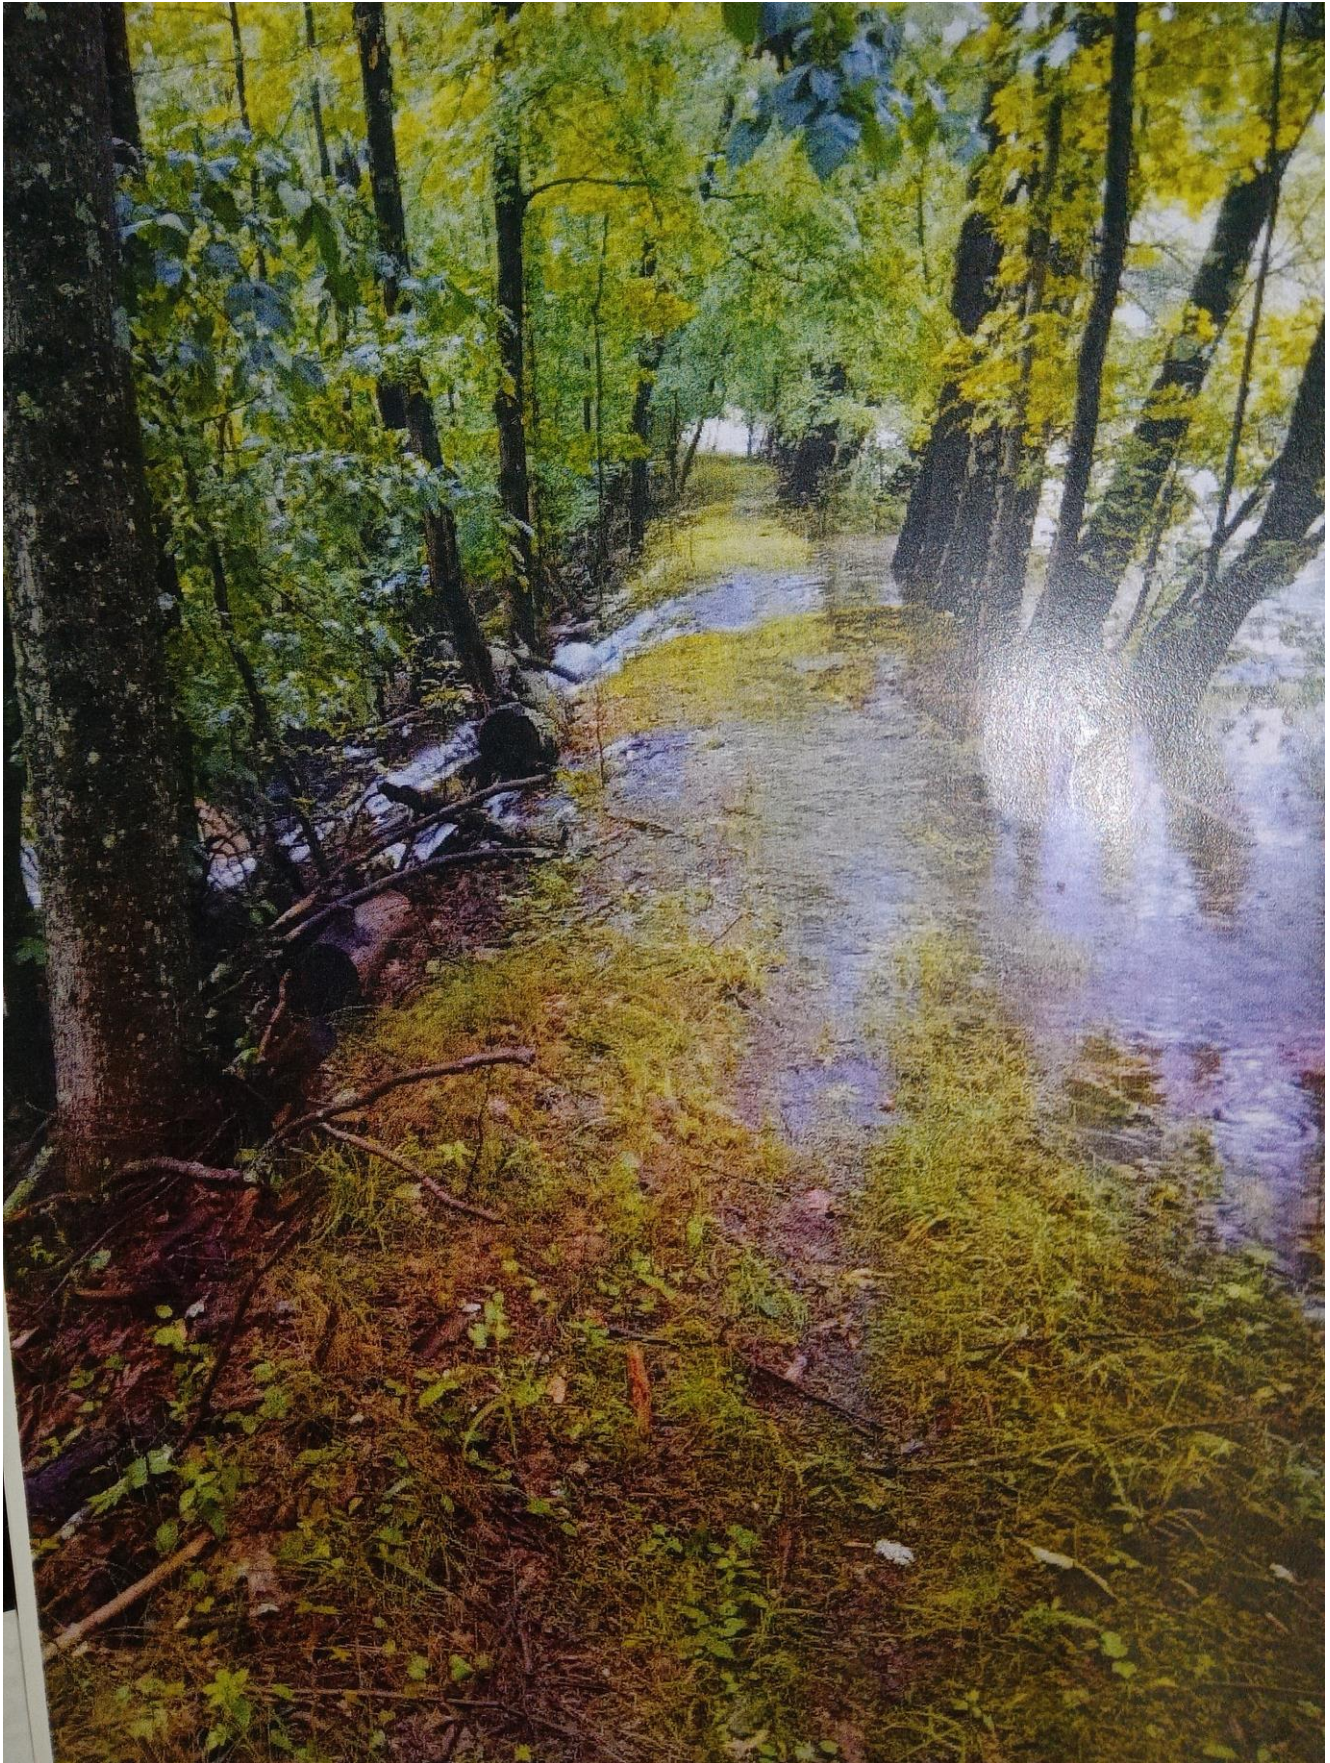
Similar to previous photo. Shows even more water breaching the berm during flood of 2021

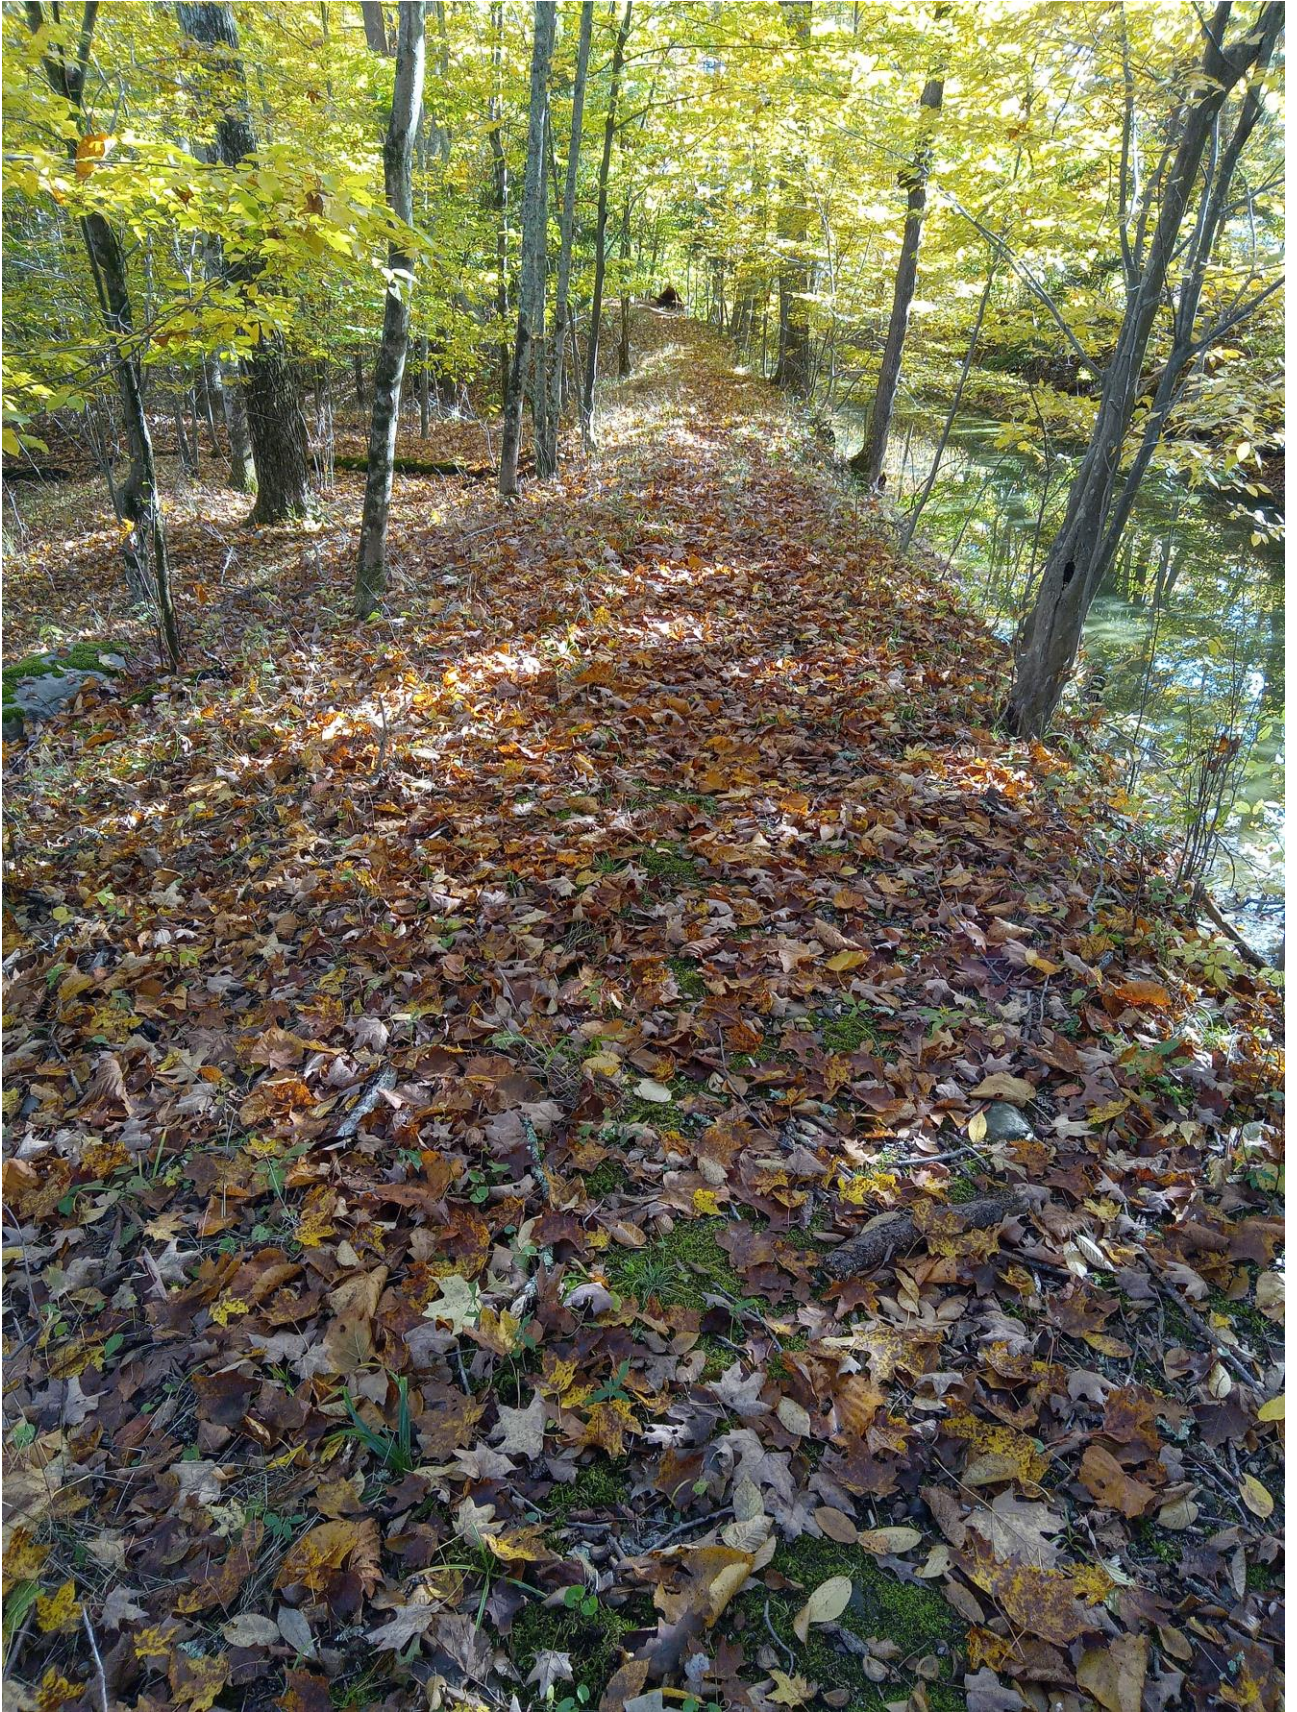
Berm after the flood, canal to right.

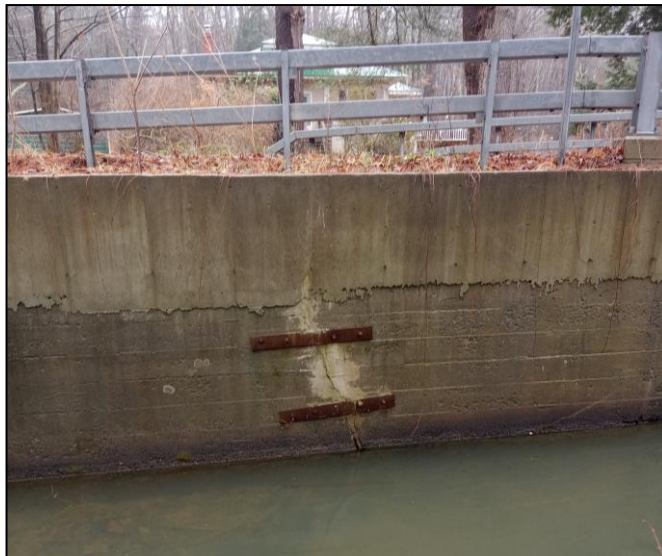
Old repair on spillway wall

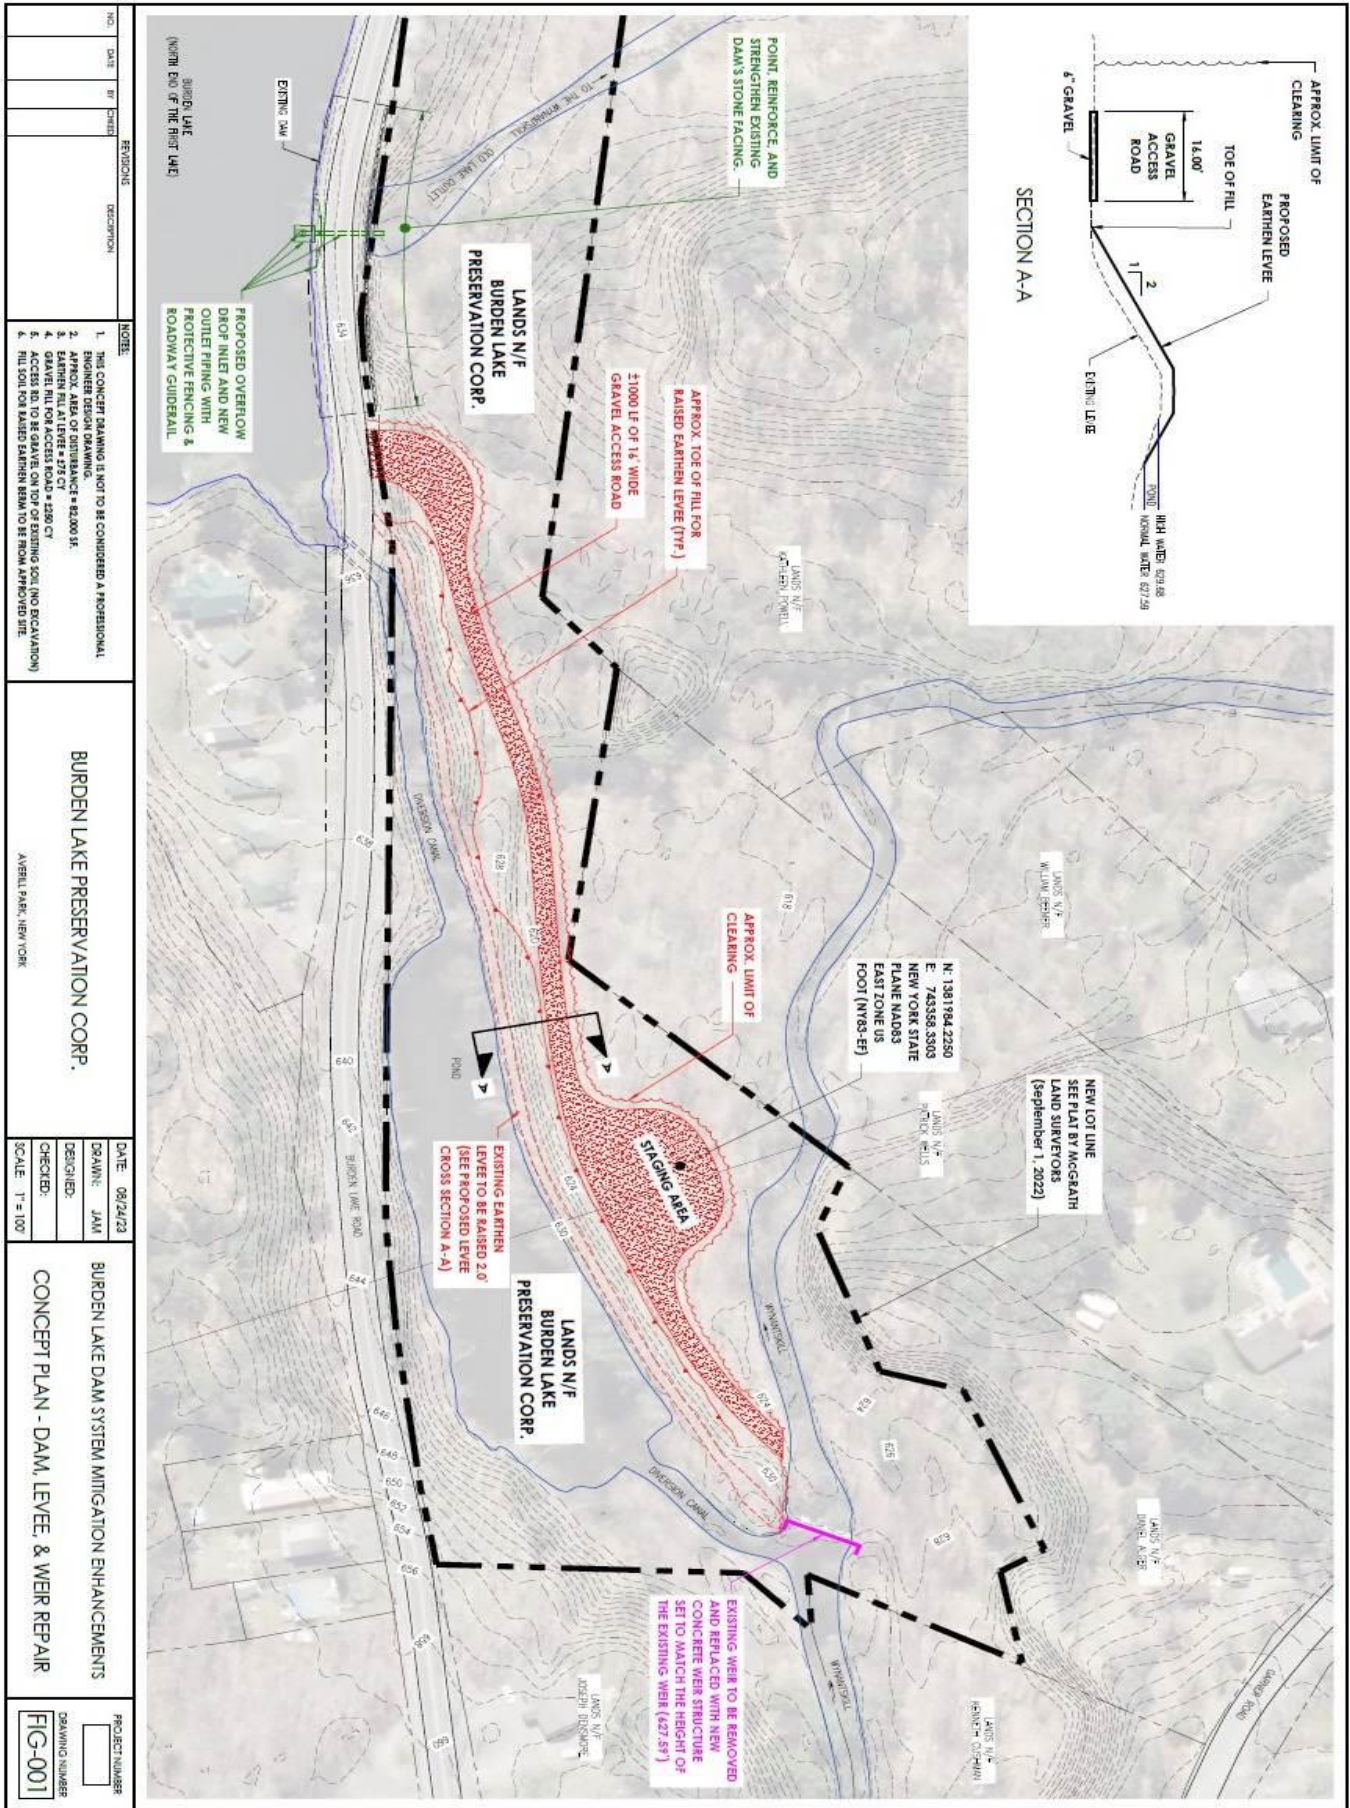
Above is the BLPC's Conceptual drawing of the needed repairs.
