# The Burden Lake Dam System:

1831 - 2024

by Larry McKeough

in conjunction with The Burden Lake Preservation Corporation

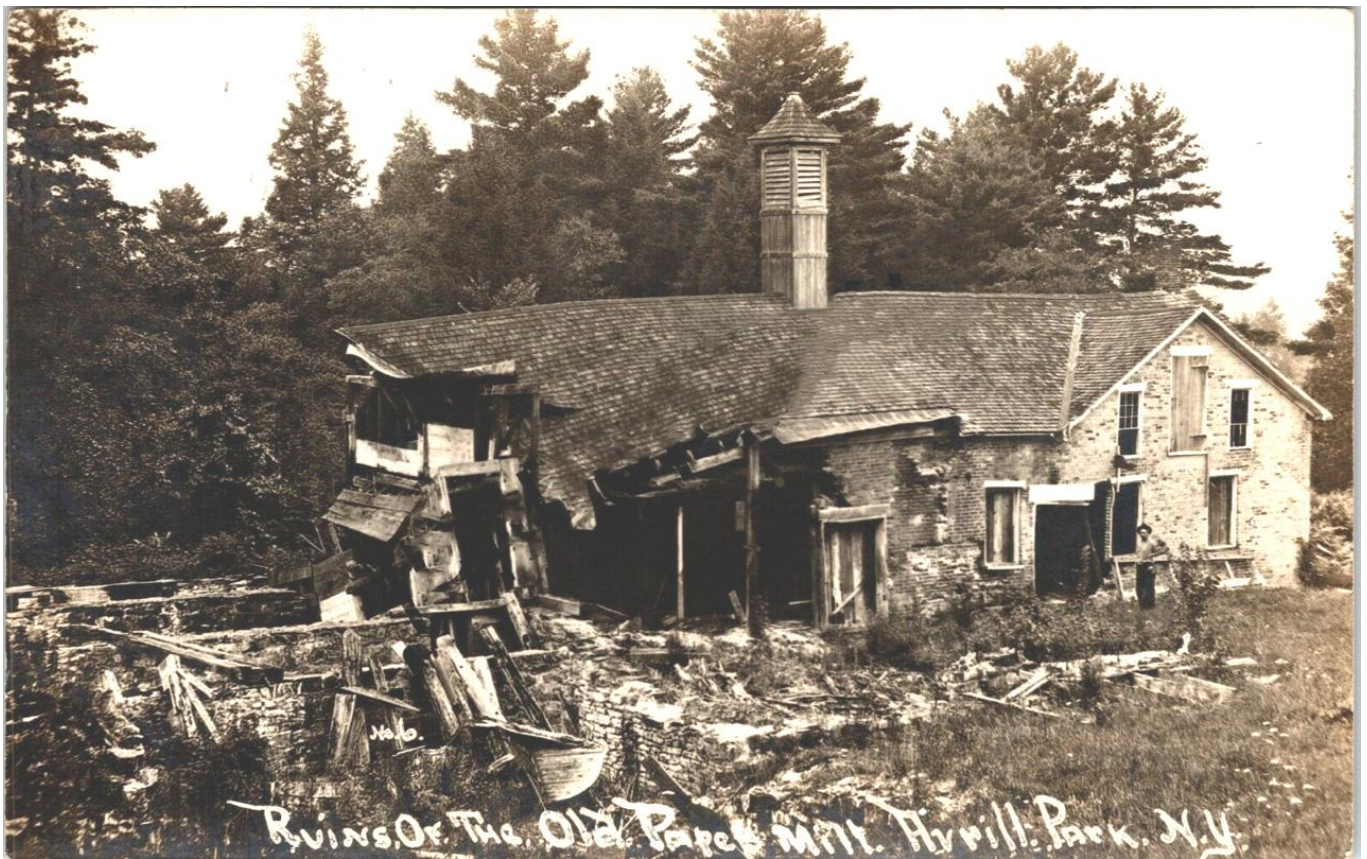
Original old photo most likely taken after the 1891 flood when the mill was severely damaged while operating as Smart's Paper Mill. (year of photo unknown)

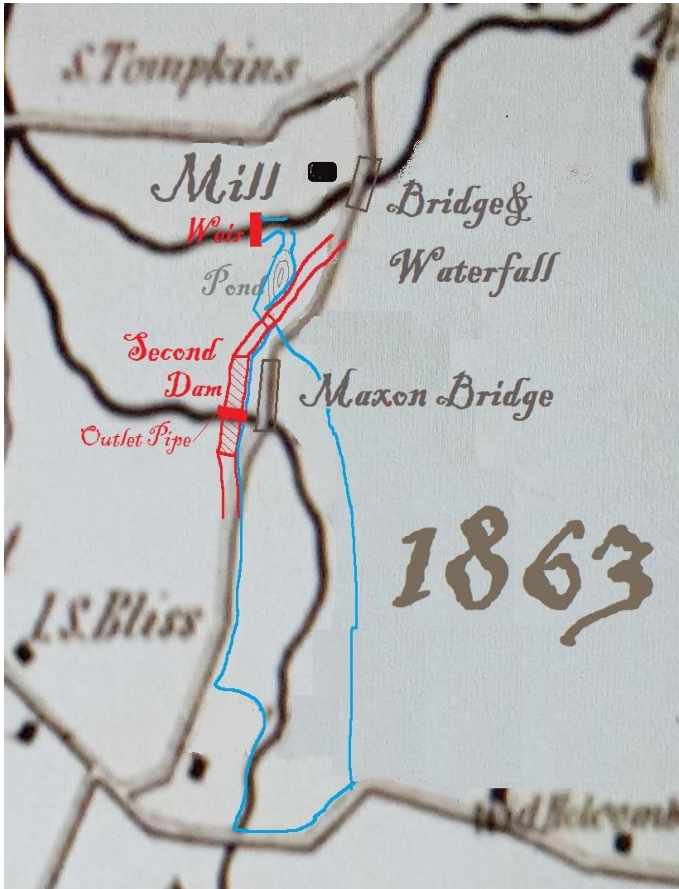
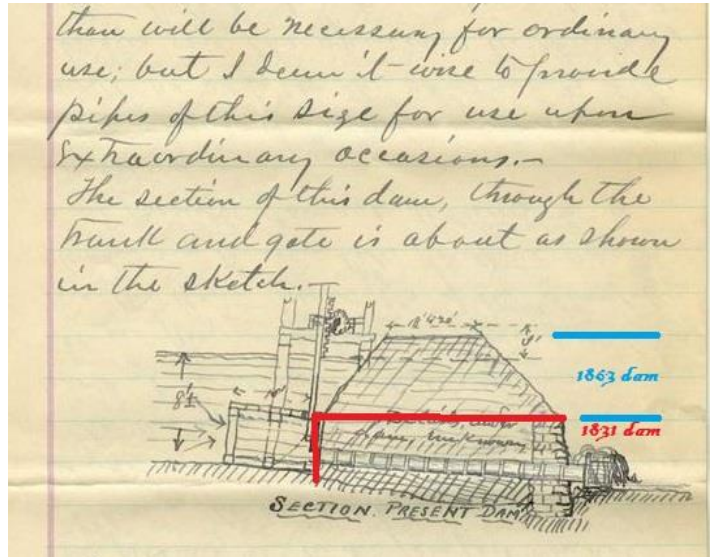
Drawing by David M. Green in 1889 showing the cross section of the dam as built in 1863. Red shows the 1831 dam, blue shows 1863 dam which was added to the top of the 1831 dam. David Green is recommending improvements to the dam which will follow.

Green's recommendations for the Burden Lake Dam which were implemented around 1890.

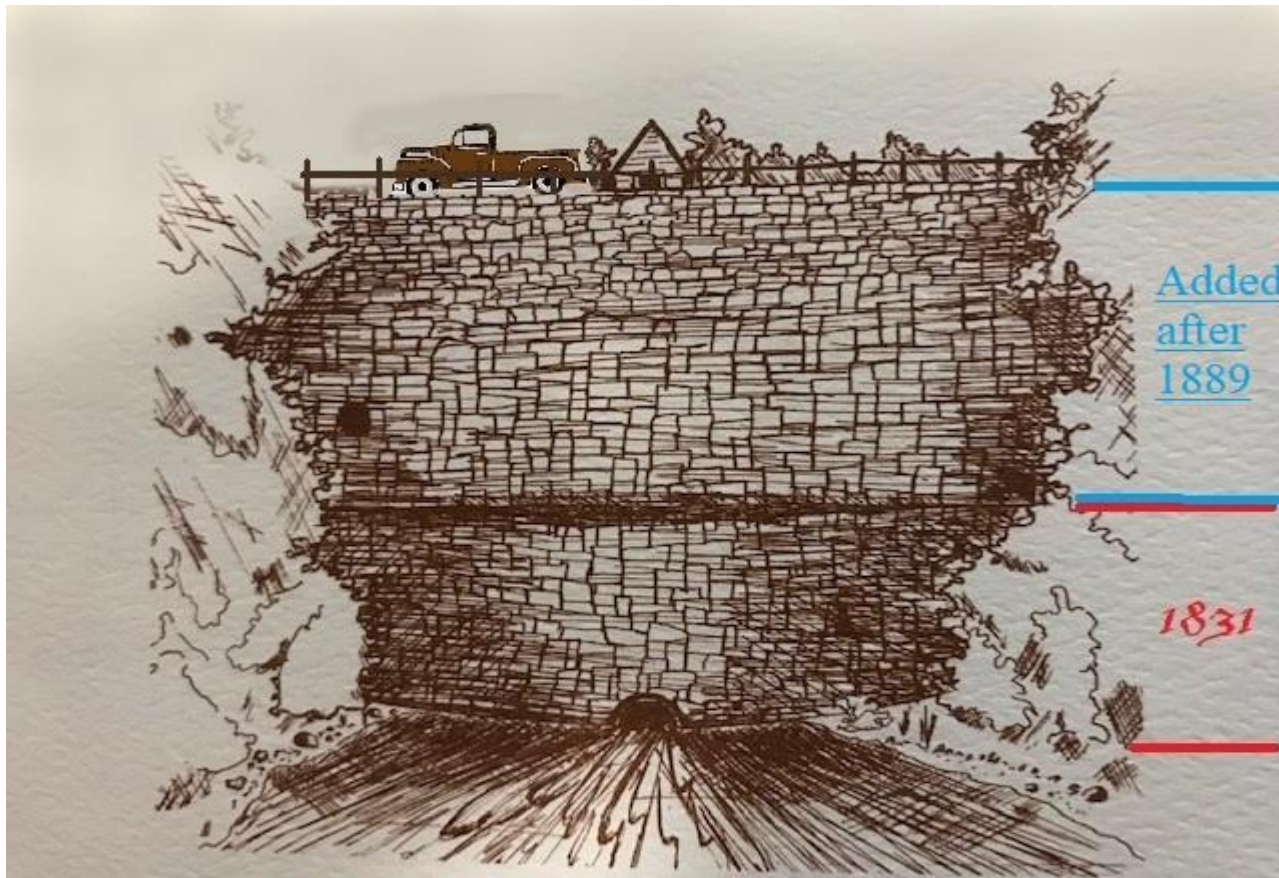
The above drawing shows the lower 1831 dam with the newer stone wall on top apparently added after 1889. There is no date on the drawing, but it must be after the County widened the road atop the dam in 1948 . It also shows the railroad track guard rails on the west side of the dam, a 1948 Dodge pickup, and on the far (lake side) of the dam you can see the roof line of the gate valve guard shack which the lake Ice took out in the 80's.

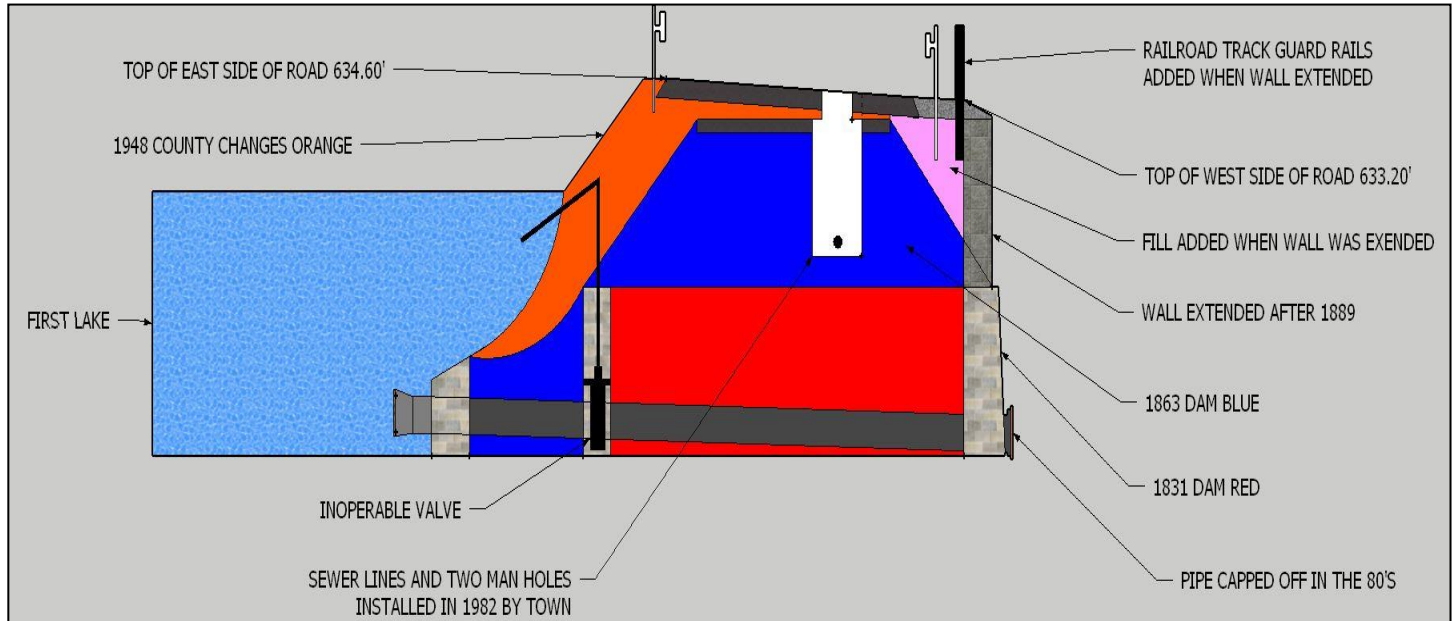
# Here is a current cross section of the dam showing the changes we believe took place.

Red = 1831 First Dam by WIA

Orange = 1948 Modifications by County

Blue = 1863 Dam added to top of 1831 Dam by WIA

White = 1982 Sewer by Town of Sand Lake

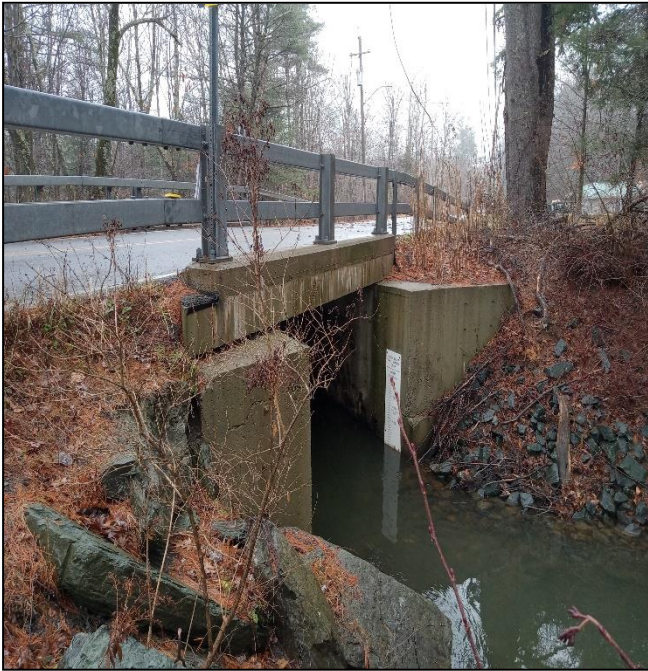
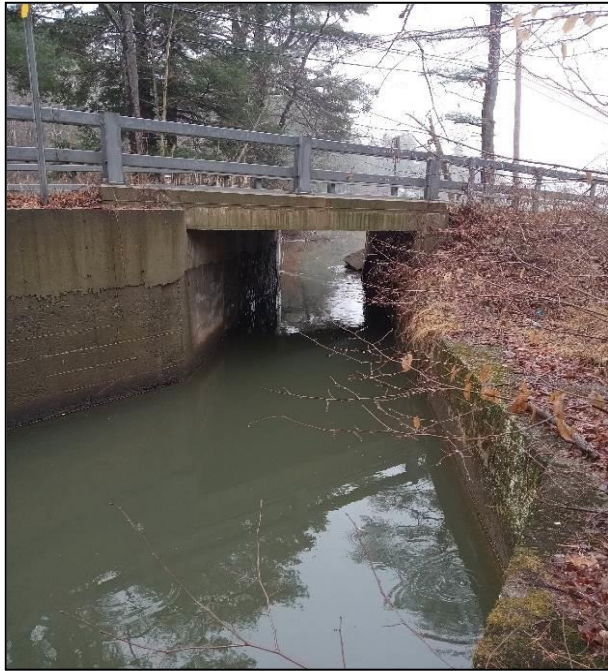
Spillway Bridge

In about 2009, the County replaced the spillway bridge and made any necessary repairs to the abutments.

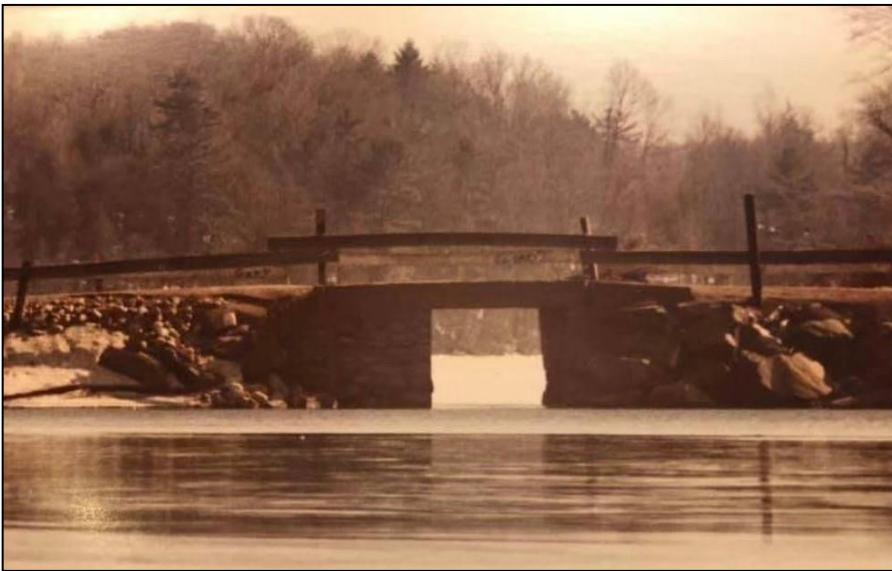
Bridge on Second Dyke Road. This structure was in place for many years. It was replaced with a 7' or 8' galvanized culvert pipe in about 1988. Photo taken from the Second Lake looking south. Photo courtesy of Vinny Robelotto. Year unknown most likely 1950's or 60's

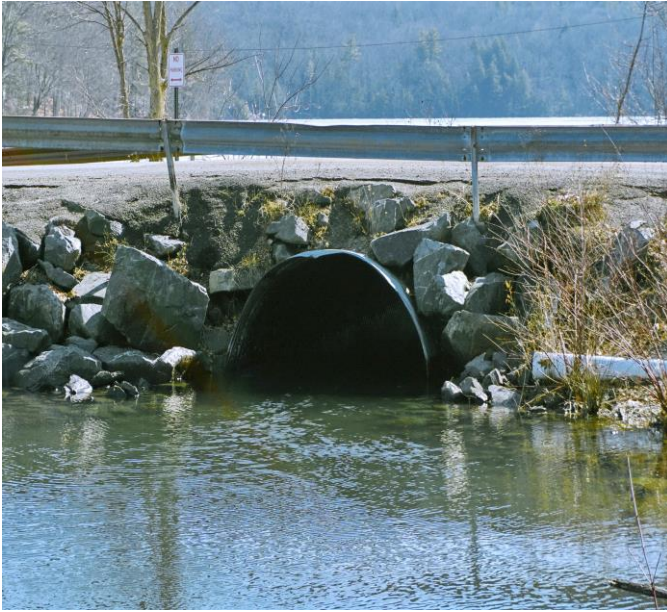
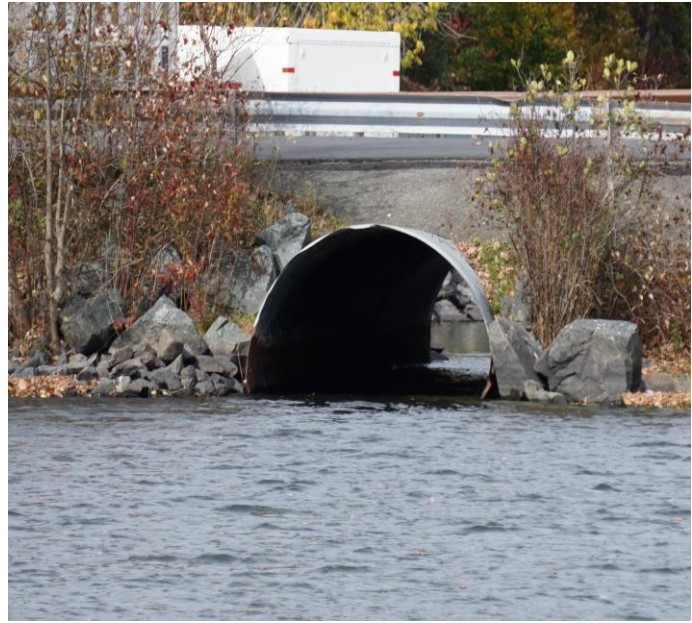
This culvert was the passageway from the Second Lake to the Third Lake from around 1988 till 2022. Photos courtesy of Dennis Ryan.

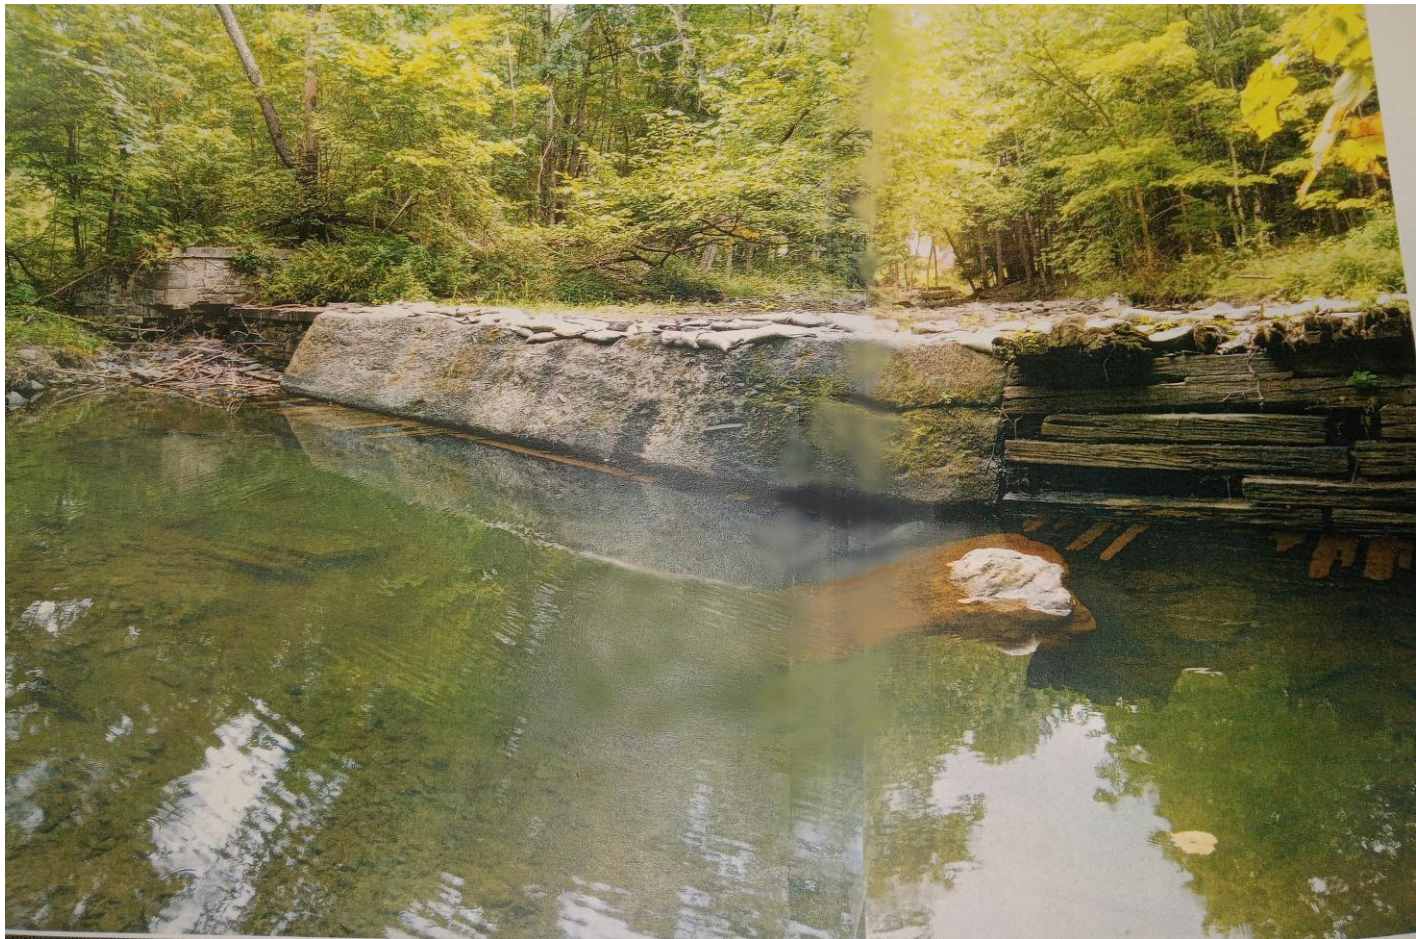
- Originally built of wood which washed away in the storm of 1891 and replaced with a concrete and cut stone structure in 1892.
- The current weir is four to five feet high, four to five feet thick, and fifty to sixty feet in length. Its cut-stone abutments on either side are failing.
- Is in unbelievably bad condition. Part of the weir fell apart and was repaired with railroad ties in the 1970's and are still in place today rotting away.
- The large granite capstones, which set the "normal" level of the 3 lakes, have all been washed off the top of the Weir with sandbags taking their place, temporarily.
- The structure is leaking in numerous places including through the 1970 temporary repair.
- The boards under the Weir appear to be deteriorating.
- The Weir has reached the end of its useful life at 130+ years old.

Weir photos were taken during drought of 2022 revealing the deteriorating condition of the structure including rotting boards underneath the Weir.

Above - Southeast Abutment  
Left – Northwest Abutment  
Both falling apart!

1. Build a construction service road from the dam on B/L Road to the Weir
2. Completely replace the Weir with the elevation set at the exact same historic elevation, incorporating a "fish ladder," if needed
3. Remove all trees and brush from the 900-foot berm; raise the Berm to 632.68' above sea level and widen the berm sufficiently to prevent a future breach. Hydroseed the top and west side of the berm. Install riprap on the east side of berm to reduce erosion.
4. Utilize the original 30-inch exit pipe under the dam by incorporating a standpipe/repared control valve (on the lake side of the dam) to allow us to make a combination drop drain and give us the ability to release excess water as needed.
5. Repair and strengthen the west side of the dam under the closed portion of Burden Lake Road
6. Divert water and snow melt from flowing off the roadway and down the west face of the dam

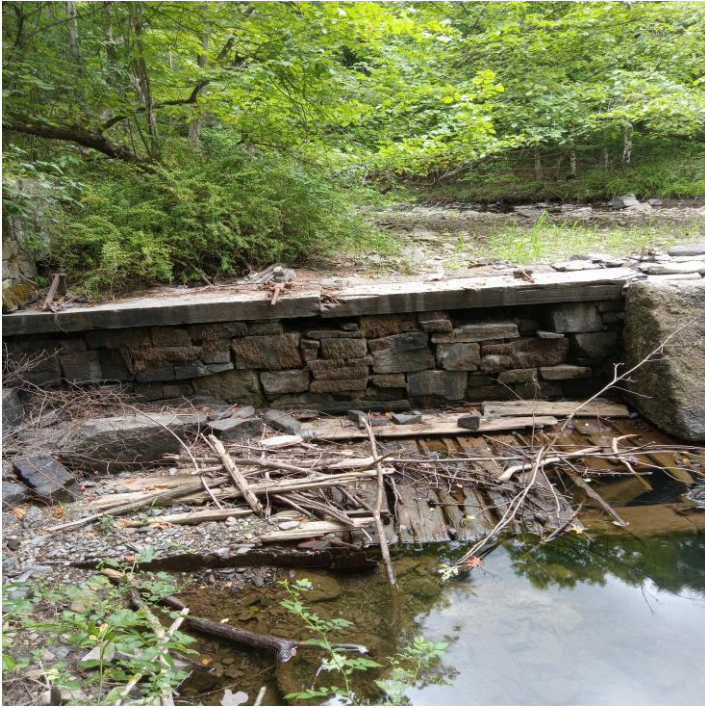
Old photo of Northwest abutment when it still had the capstones. Only one capstone remains today.

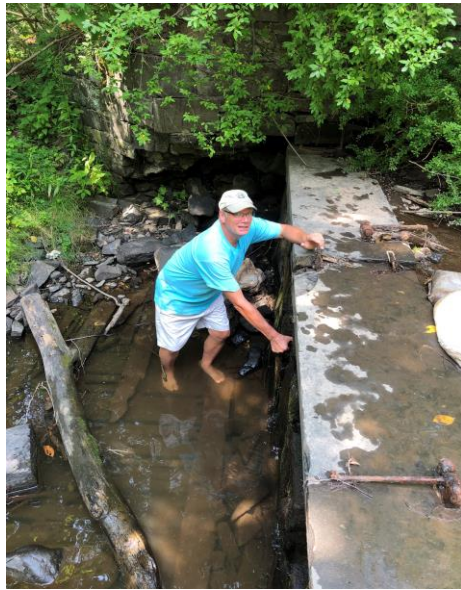
Old photo shows some of the cap stones still in place. Larry McKeough plugging a leak in the Dam (actually the Weir) with his thumb, trying to save Burden Lake! Photo courtesy of Paul Ashline.

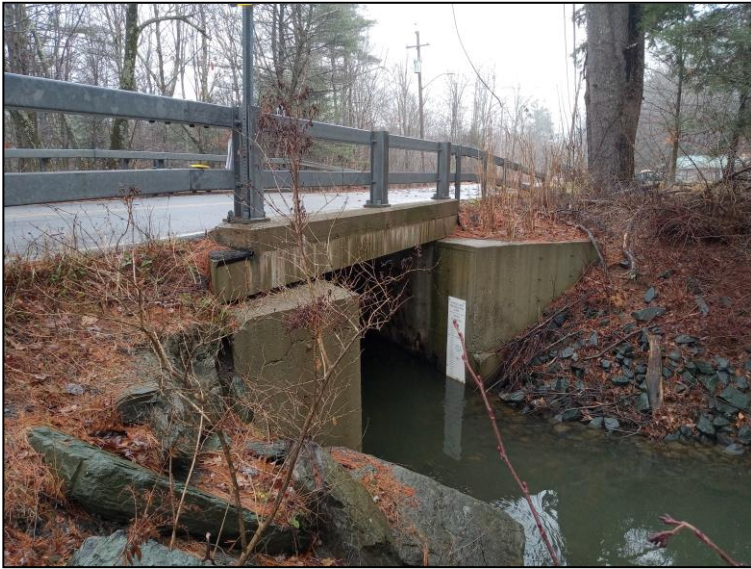
Lake side of Spillway

- In good condition
- Bridge replaced in 2009.
- Abutments may need some repairs.
